## May 2014 Construction Photos

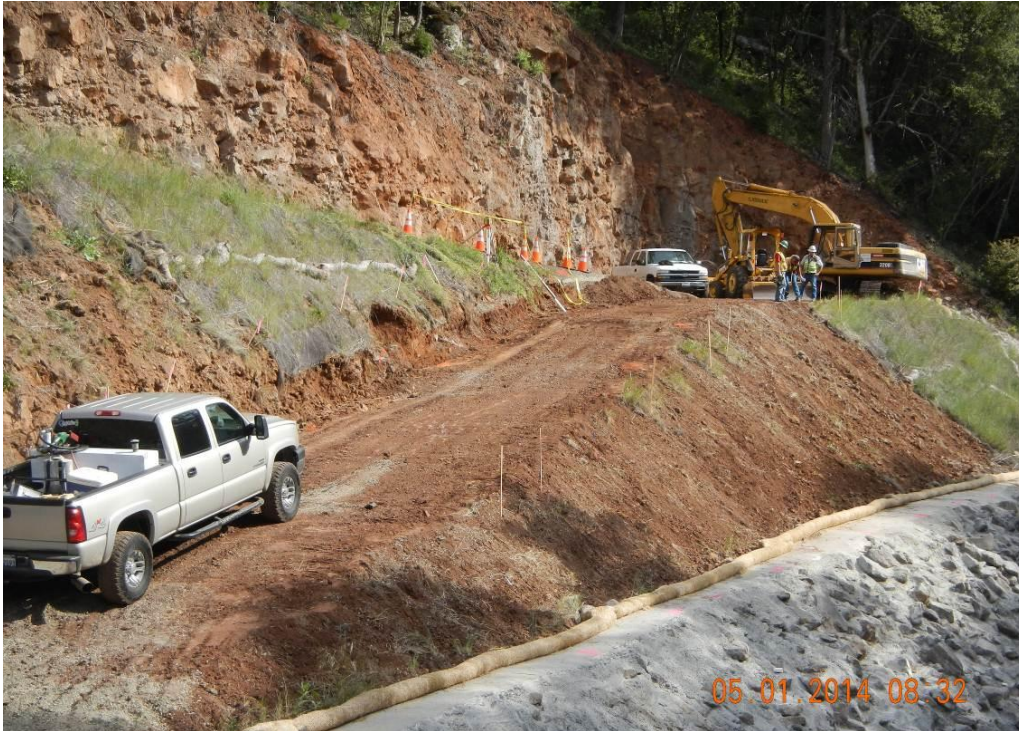
*North Battle Creek Feeder Diversion Dam:* The contractor has removed the roadway asphalt in preparation for installing the precast concrete block wall.

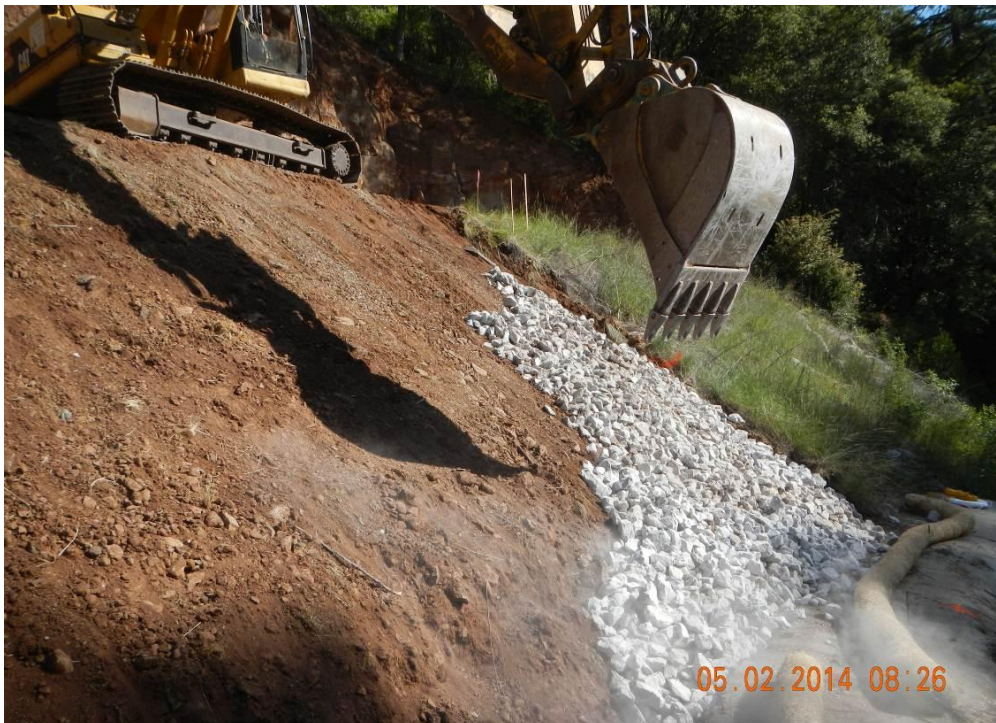
*North Battle Creek Feeder Diversion Dam:* The contractor is placing the Caltrans 72.2.02 A size No. 3 backing materials for the concreted rock slope protection.

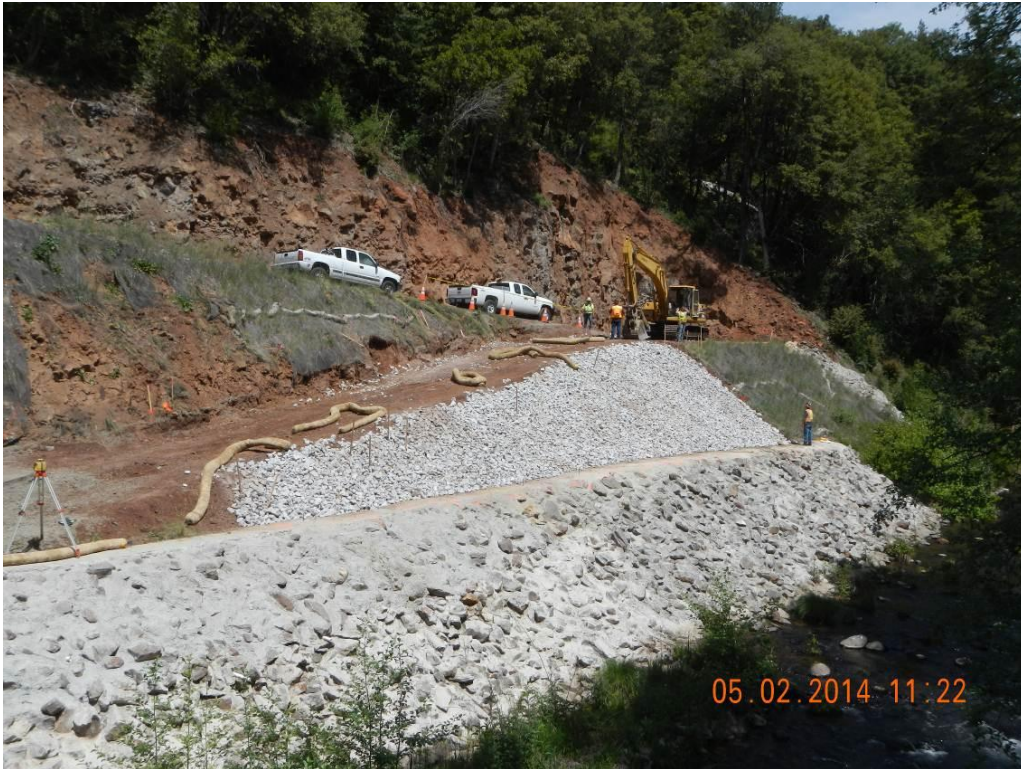
*North Battle Creek Feeder Diversion Dam: The contractor completes placement of No. 3 backing materials on the 1.5:1 slope for rock slope protection.*

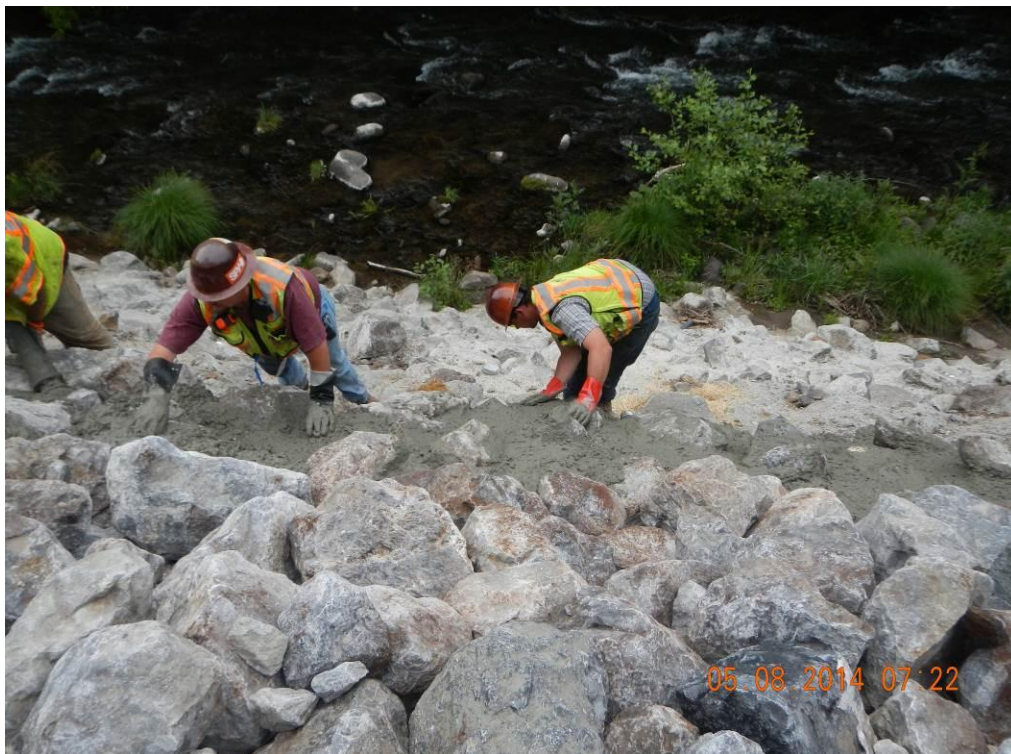
*North Battle Creek Feeder Diversion Dam: The contractor is placing concrete in the voids of the rock slope protection to a minimum depth of 10-inch.*

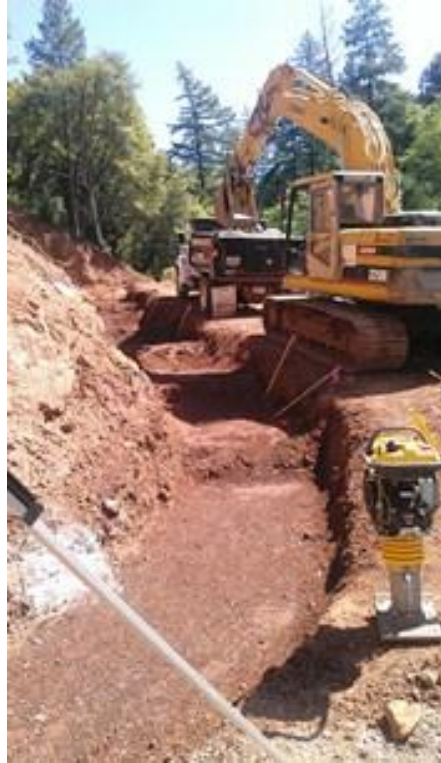
*North Battle Creek Feeder Diversion Dam:* The contractor is using the excavator to cut the sub-base for the step elevations of the precast concrete wall.

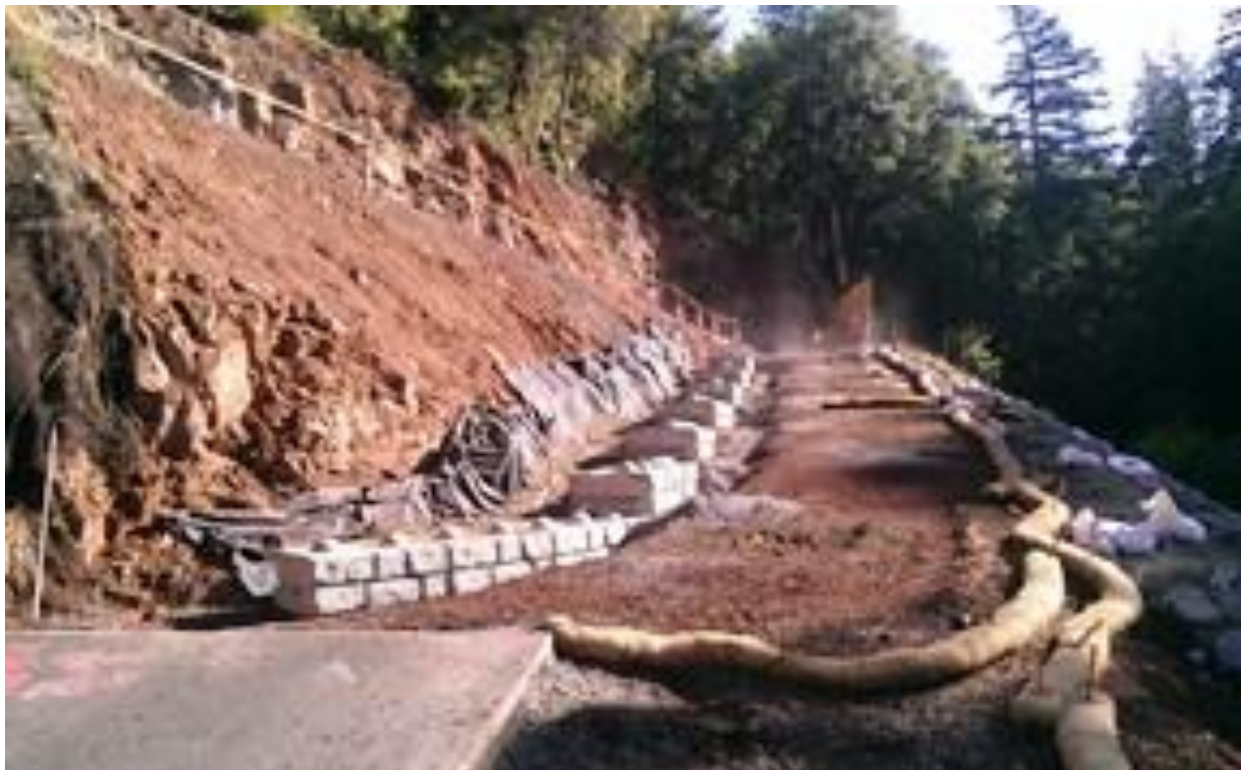
*North Battle Creek Feeder Diversion Dam:* The contractor is laying the blocks for the precast concrete wall and installing the drain pipe behind the wall.

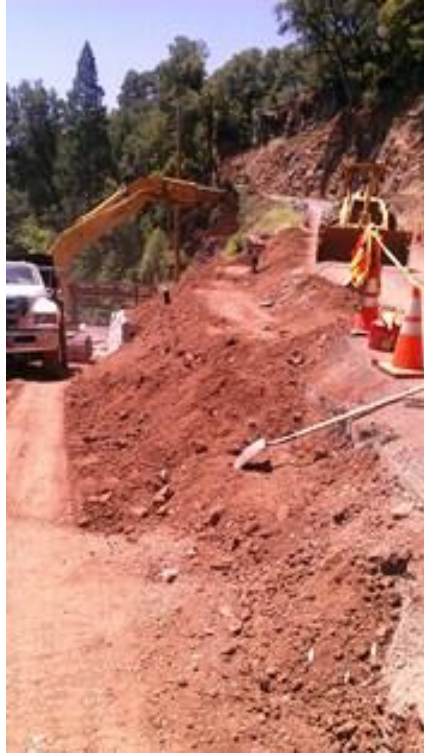
*North Battle Creek Feeder Diversion Dam:* Backfilling operation behind the precast concrete block wall.

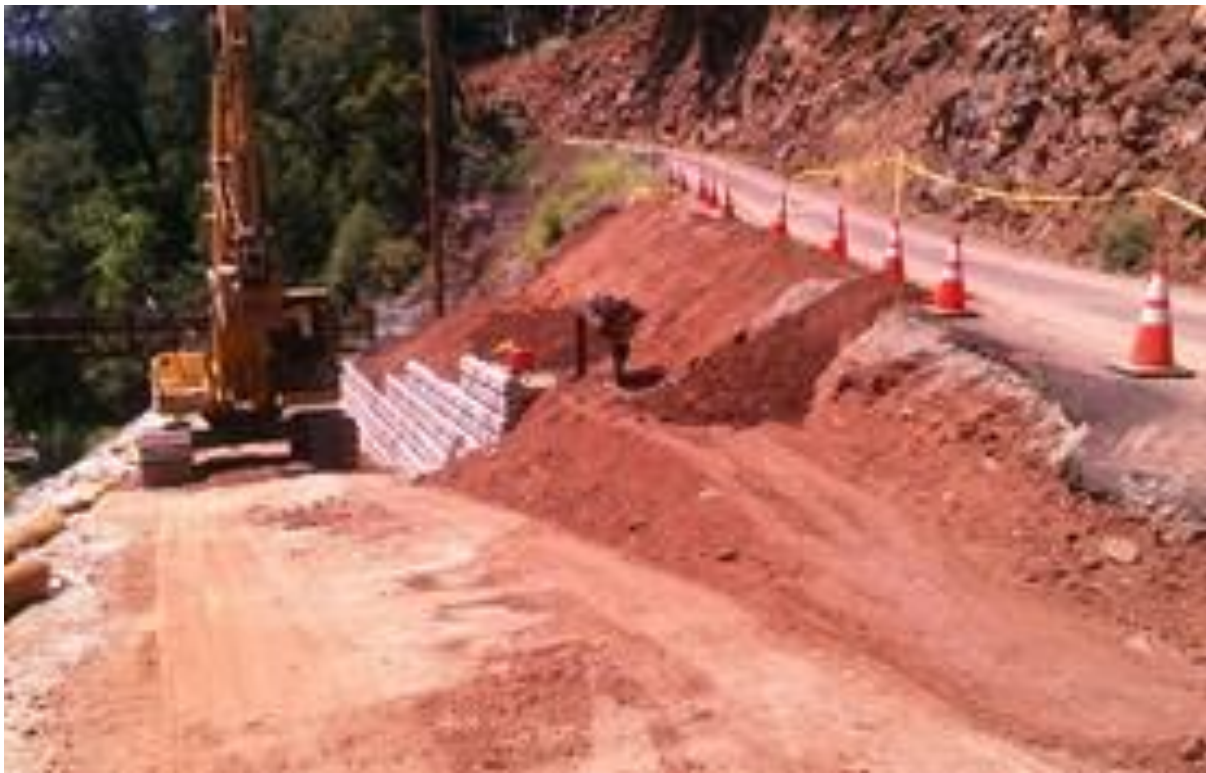
*North Battle Creek Feeder Diversion Dam:* The contractor is backfilling the precast concrete block wall and compacting the fill in 8 – 12 inch lifts.
